**SITUATION REPORT
GOLD KING MINE RELEASE INCIDENT
U.S. ENVIRONMENTAL PROTECTION AGENCY**

Subject: EXECSUM / SITREP #51
Gold King Mine Release Incident
San Juan County, Colorado
Latitude: 37.8945 Longitude: -107.6384

Date: 25 November 2015

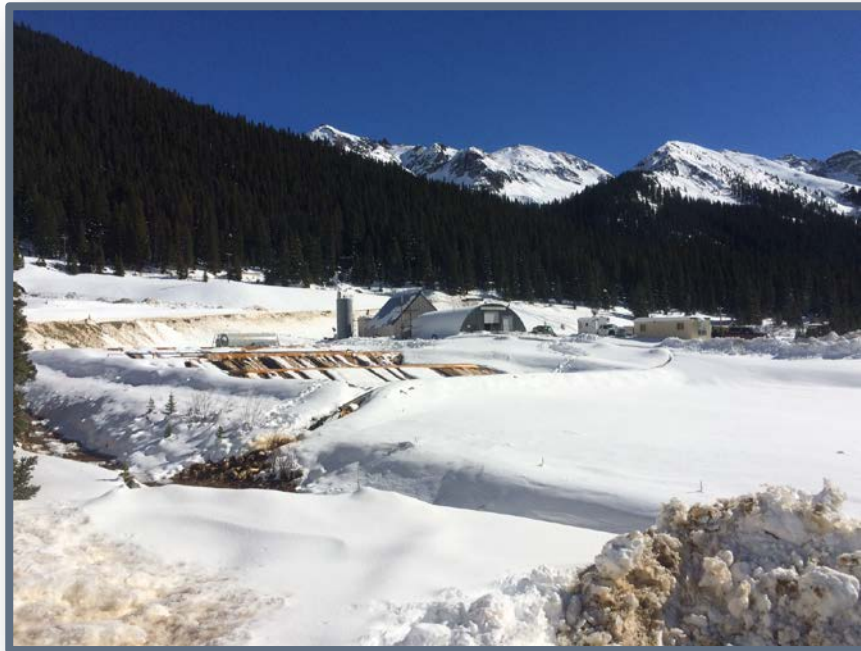
Current conditions at Gladstone area near Gold King Mine.

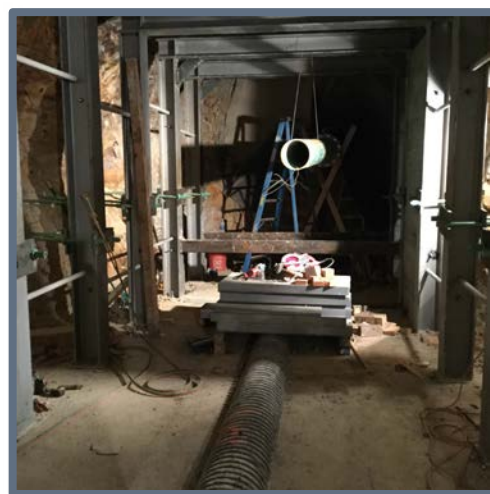
Steel sets and piping installed inside the Gold King Mine.

- Completed concrete pour for steel sets inside Gold King Mine.
- Started steel set and lagging installation. Steel sets 1-5 were installed with lagging and rock bolts, and anchored to the adit.

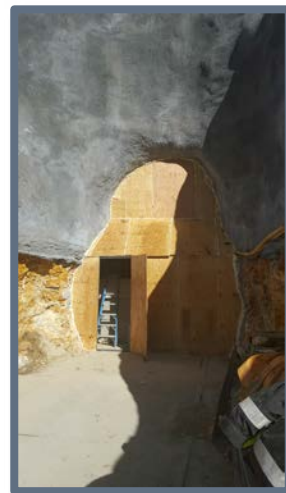
Air seal installed at the Gold King Mine portal to prevent freezing inside the mine.

- All water from the mine is gravity flowing to the Gladstone treatment system.
- Installed air-tight seal at mine portal to prevent air flow and potential freezing inside the mine.
